Monitoring Data RecordProject Title: R-2417BB (Site 6) COE Action ID: 200201326Stream Name: \_\_\_\_\_ DWQ Numbers: 3378City, County and other Location Information: Lee County, Sanford Bypass (Sta. 540+20 to 555+00 -L- RT.)Date Construction Completed: Water was turned into the stream in Oct. 2006. Streambank reforestation was completed in Jan. 2007.Monitoring Quarter: ( 2 ) of 8Ecoregion: \_\_\_\_\_ 8 digit HUC unit: 03030004

2nd Quarter – August 2007

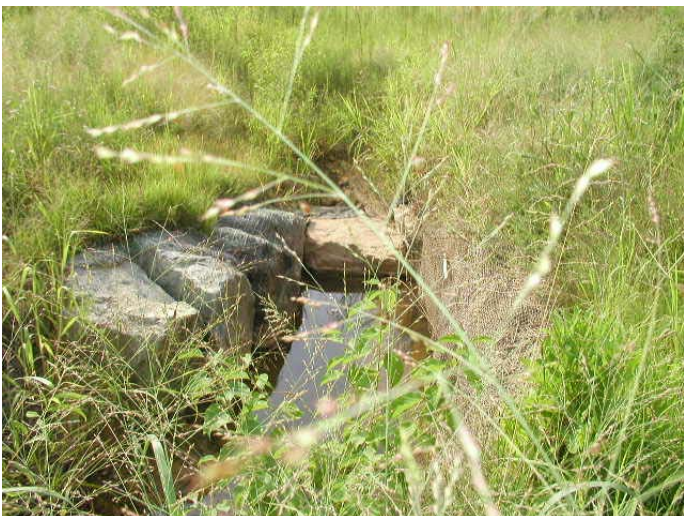
Photo Point #6 (Upstream)

8/7/07	PP #6 Upstream Sta. 546 +75	PP #7 Downstream Sta. 545+60	Station Number	Station Number	Station Number
Structure Type	Crossvane	Crossvane			
Is water piping through or around structure?	Water is piping through the crossvane	Water is piping through the crossvane			
Head cut or down cut present?	Slight headcut				
Bank or scour erosion present?					
Other problems noted?
